# Fate of Hg in Synthetic Gypsum used for Wallboard Production

Jessica Marshall  
USG Corporation

Gary Blythe and Mandi Richardson  
URS Corporation

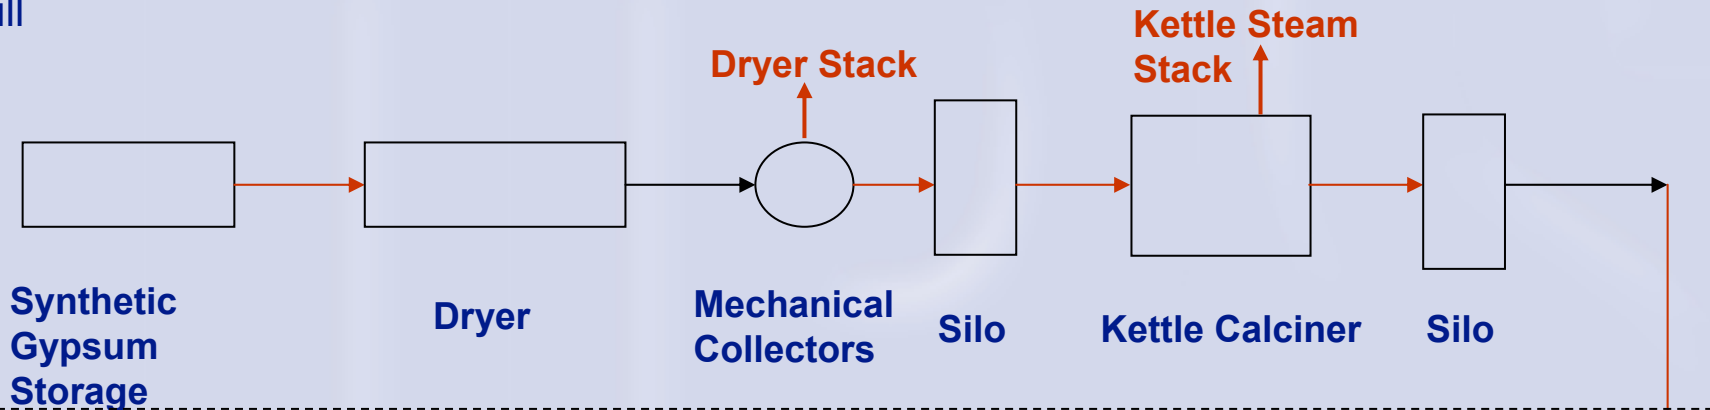
# Locations to be Sampled (in red)

- Measure Hg concentrations in raw gypsum dryer and calciner stacks, board dryer stack
- Measure Hg concentrations in process input and wallboard product streams
- Close Hg balance around wallboard plant
- Conduct additional laboratory investigations
  - Hg leaching from wallboard product by TCLP
  - Comparison of Hg in synthetic vs. natural gypsums
  - Laboratory simulation of Hg losses during calcining
